Feasibility Study
Mamaroneck Reservoir Dam
NYSDEC ID #233-0866
Village of Mamaroneck, NY

September 2015

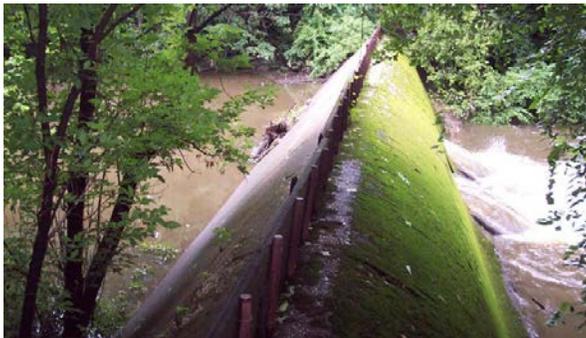
Visual observations made during a GHD (formerly Stearns & Wheeler) site visit (October 7, 2004) were similar to the observations noted in the Phase I Inspection Report. The overall condition of the embankment of the dam appears good, but has changed. The concrete apron at the embankment crest is further deteriorated and covered in vegetation. The area directly surrounding the gatehouse (filter house) has been backfilled to continue the upstream slope to the dam. The earthen embankment is now covered with vegetation and trees.

Figure 1 Photo of moss on crest in 2004

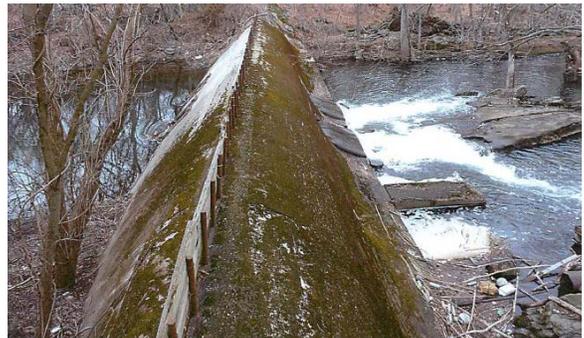
Photographs were taken of the Mamaroneck Reservoir Dam by the NYSDEC during the March 30, 2015 inspection. Visual observations of these photos are similar to the observations noted in the Phase I Inspection Report and the GHD (formerly Stearns & Wheeler) site visit. The condition of the embankment has continued to change. Vegetation on and near the dam continues to grow, and moss on the dam is spreading. Figures 1 and 2 show evidence of moss growth. At the time of the 2004 site visit (Figure 1), moss was growing only on most of the downstream side of the dam, compared to the 2015 DEC inspection picture (Figure 2) that shows moss growing on all of the downstream side and parts of the upstream side. It is also clear from these photos that trees have not been removed and continue to grow. Evidence of structural change from the 2004 and 2015 site visits is not apparent.

Figure 1 Photo of moss on crest in 2015
(Taken from NYSDEC letter dated 3/30/2015)
